## Using Infrared for Residential Energy Surveys

*Dave McCullen  
Sumter Electric Cooperative Inc.*

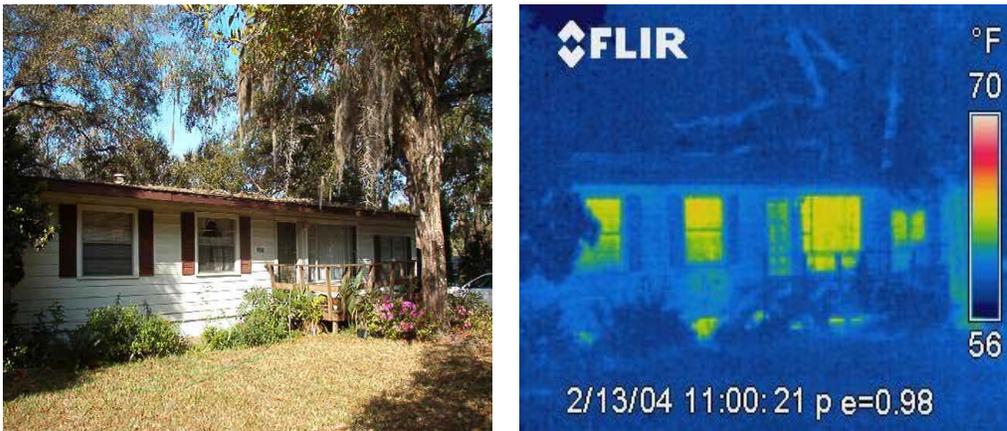
*Figure 1. Areas of winter heat loss in a single-story existing dwelling*

New home construction and insulation requirements have improved greatly over the last few years. Most states either have or are working on energy rating programs that conform with the Federal Environmental Energy Efficiency guidelines; however, most existing homes and quite a few of the new ones built today have areas that could be greatly improved. In Figure 1, this home looks cozy enough in this winter setting, but infrared shows areas of significant heat loss through the windows, doors, and even under the floor level in the crawl space. Ceiling insulation here appears adequate, but floor insulation is lacking.

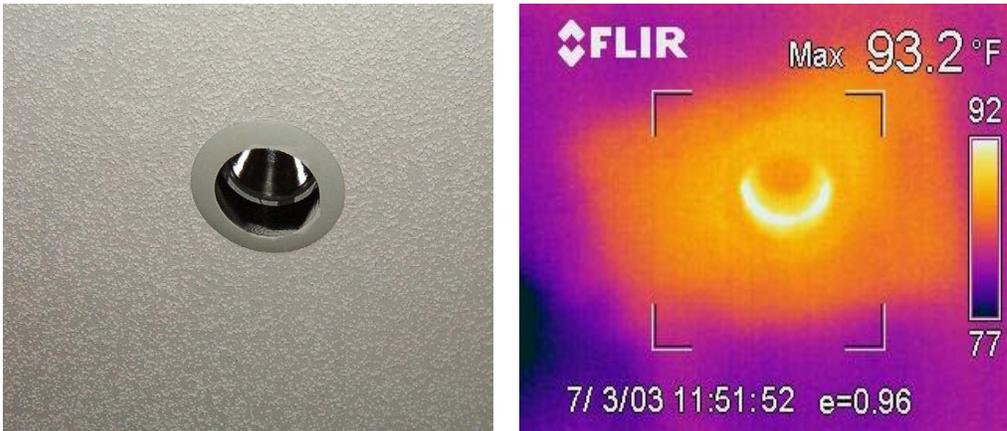
*Figure 3. Ceiling penetration and insulation problem*

Ceiling penetrations can be significant heat gain or loss areas if numerous and not adequately sealed. In Figure 3, the fixture was not on, and the thermograph revealed that the insulation around the fixture was not adequate. Attic inspection revealed that the insulation had been pulled away from the fixture on all sides and that the fixture was not sealed.

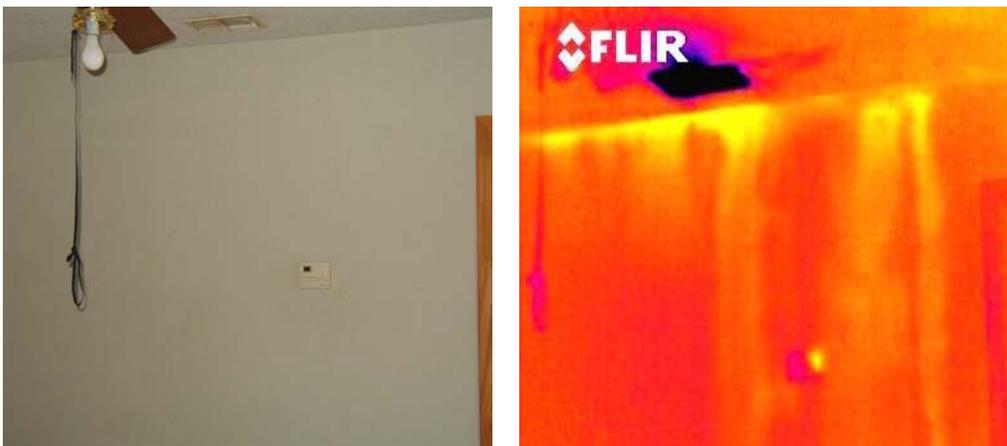
*Figure 4. Thermal ducting inside a hollow wall behind the thermostat*

Without the use of infrared, one of the hardest problems to find in a home is the existence of thermal ducting inside the wall structure affecting the regulation of the system. This phenomenon affects the HVAC running time by infiltration of humidity and heated air into the conditioned space. It can also affect the thermostat by heating or cooling the wall behind it, thereby greatly extending the time the thermostat calls for conditioning. Figure 4 illustrates this phenomenon very clearly. The return was cut through a hollow wall, and the passage was not sealed from the wall cavity. When the unit was running, the resulting low pressure inside the return passage lowered the pressure inside the wall, and hot attic air moved in to replace it. The thermostat visible on the wall was set at 80°F, but the wall temperature just under it was 87°F. This caused the unit to keep running almost constantly. Without the thermograph, this problem would be difficult, if not impossible, to find. Figure 5 shows the same ducting situation in another home during the winter heating season. Notice the cooling of the wall behind the thermostat.

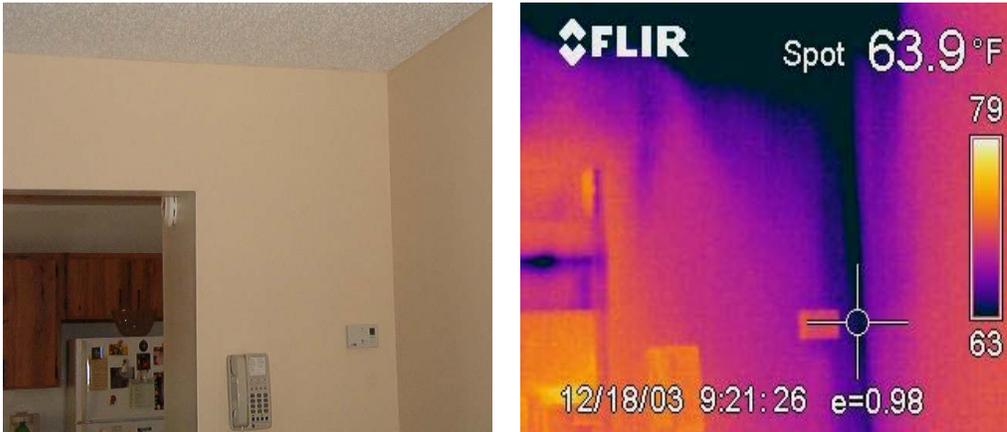
*Figure 5. Cold air being drafted in a hollow wall behind the thermostat*

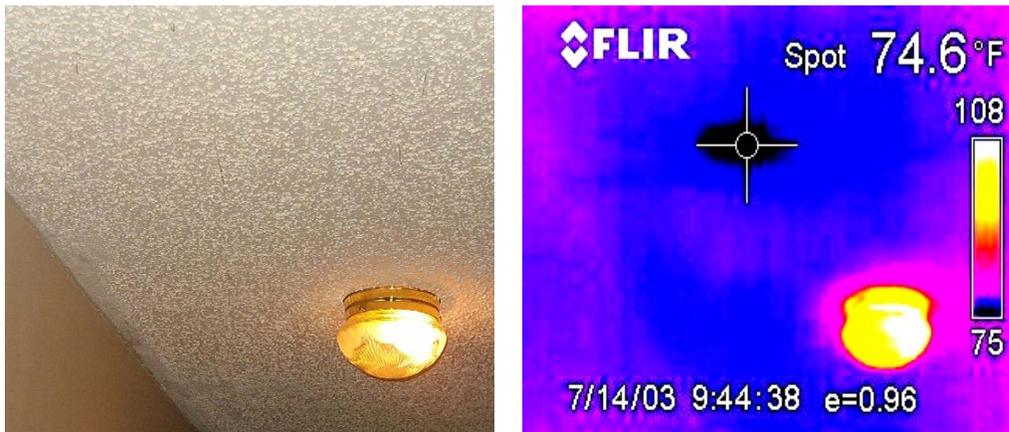
Figure 7. Cold spot on hall ceiling caused by supply junction leak in attic over ceiling board

Figure 7 shows a cold spot on the hallway ceiling that indicated a possible leak in the supply system in the attic of this home. Attic inspection showed exactly that, as seen in Figure 8. In fact, the entire supply ductwork system in this home was leaking significantly at every junction, as well as the connection with the ceiling supply inlets, losing conditioned air into the attic. The thermograph, showing a cold spot where none should be, led to a significant find that otherwise could easily have been missed.

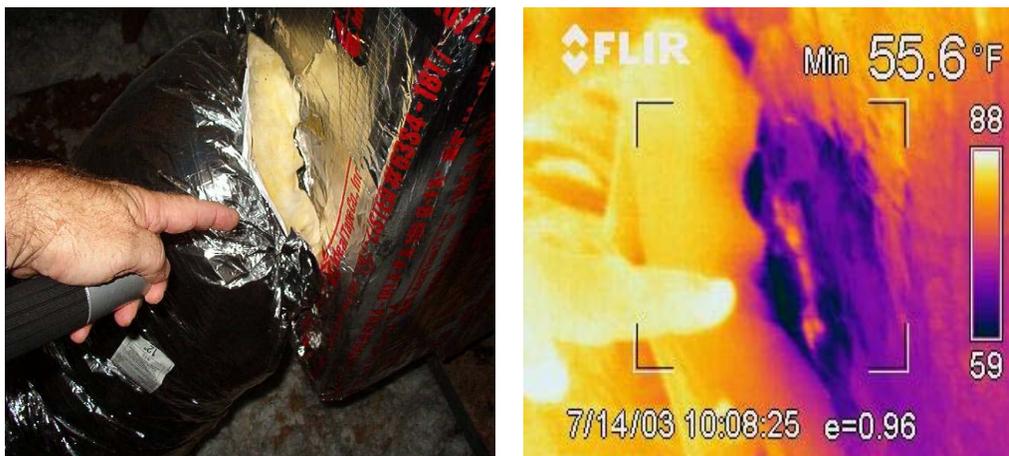
Figure 8. Supply junction of flex duct and disbursement box that was not sealed or taped

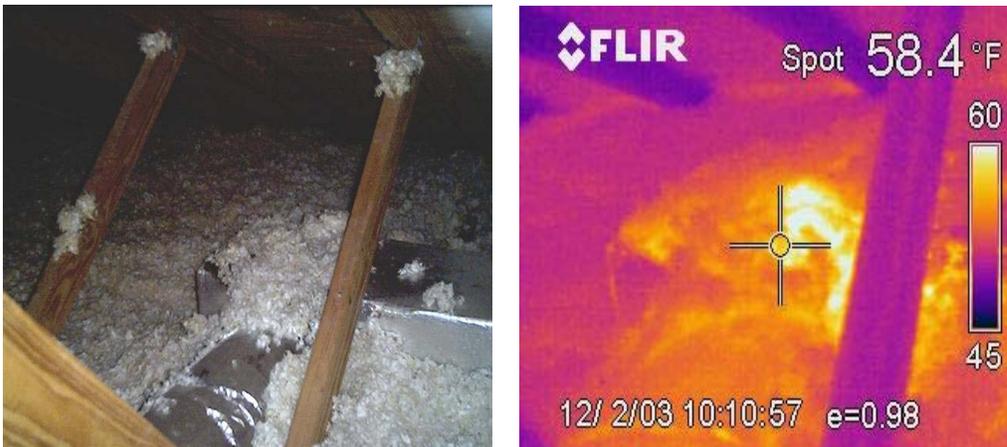
The most difficult supply leaks to find are those that are buried under the blown-in insulation. These can go undetected very easily, but in Figure 9 we see that the infrared will pick up the conditioned air infiltrating the insulation and indicate the leak. This leak was found in January during the heating season and was substantial, as seen by the amount of heated air shown infiltrating the insulation.

*Figure 9. Supply leak showing heat loss under blown-in insulation*

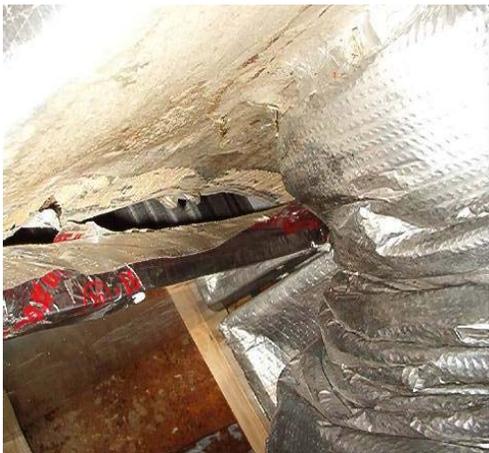
Return system leaks can greatly increase the amount of time that the HVAC system runs. If the return ducts are in the attic space, very hot, moist air can be drawn into the system, causing extended running times. In this situation the supply air will be significantly warmer than required, causing the unit to run longer to reach the thermostatic cut off. Also, because of the higher moisture, the unit must also run even longer to reach the dew point for conditioning the air. Figure 10 shows a leak in the return plenum at the air handler in the attic of a home in summer pulling in hot, moist air. The infrared shows the temperature of the coil that is visible inside the air handler at 44.2°F. The air in the attic was over 80°F. This leak was found by scanning the plenum with the infrared and noting the cold spot. Visual inspection with a flashlight found the problem. This home had all the symptoms: high humidity, unit running constantly, and very high utility bills.

*Figure 10. Large leak in return plenum at air handler*
