Finding termites with thermal imaging

Ken James and David Rice

Directors, Termicam Pty Ltd, Melbourne, Australia

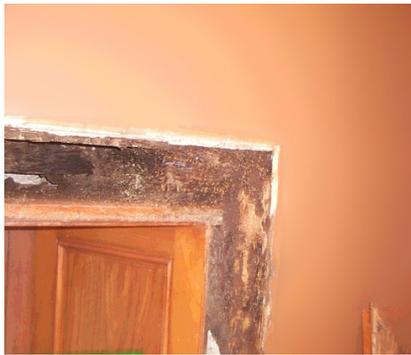
Fig 1a. Visible image of door jam, no evidence of termite infestation

The images in **Figure 1** below are an example of how thermal images can detect heat patterns and can be compared to visible images to identify the location of a termite infestation. The images were taken in a house in Australia, in May 2002 during an inspection and show the top section of a doorway. The normal visible image taken with a conventional camera does not indicate any termite activity but a thermal imaging camera reveals a hot spot that shows as yellow in the top right hand corner of the door jam. This is where the termites were very active and had eaten away most of the wood material. This technology allowed an early detection of the termite problem, and eradication could proceed before the damage was too great, thus saving the owner thousands of dollars in repairs at some future date.

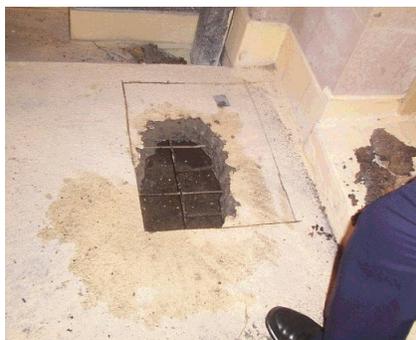
Fig 4. Hole in concrete floor, to destroy termites found with thermal imaging.

One example of this is parliament house in Brisbane, Australia. TermiCam started thermal imaging at Brisbane parliament house in 1999. After finding a heat pattern out on the balcony in March 2001, a large nest in the floor of the balcony was indicated. This was around about the second floor in what they call the reading room. The balcony was pulled up in September 2001 (**Figure 4**) by cutting a hole in the concrete slab and a termite nest was revealed.
